A518 & A618 Chrysler Automatic Transmission

PRODUCT BULLETIN

Driveshaft Yoke Does Not Fit the Output Shaft

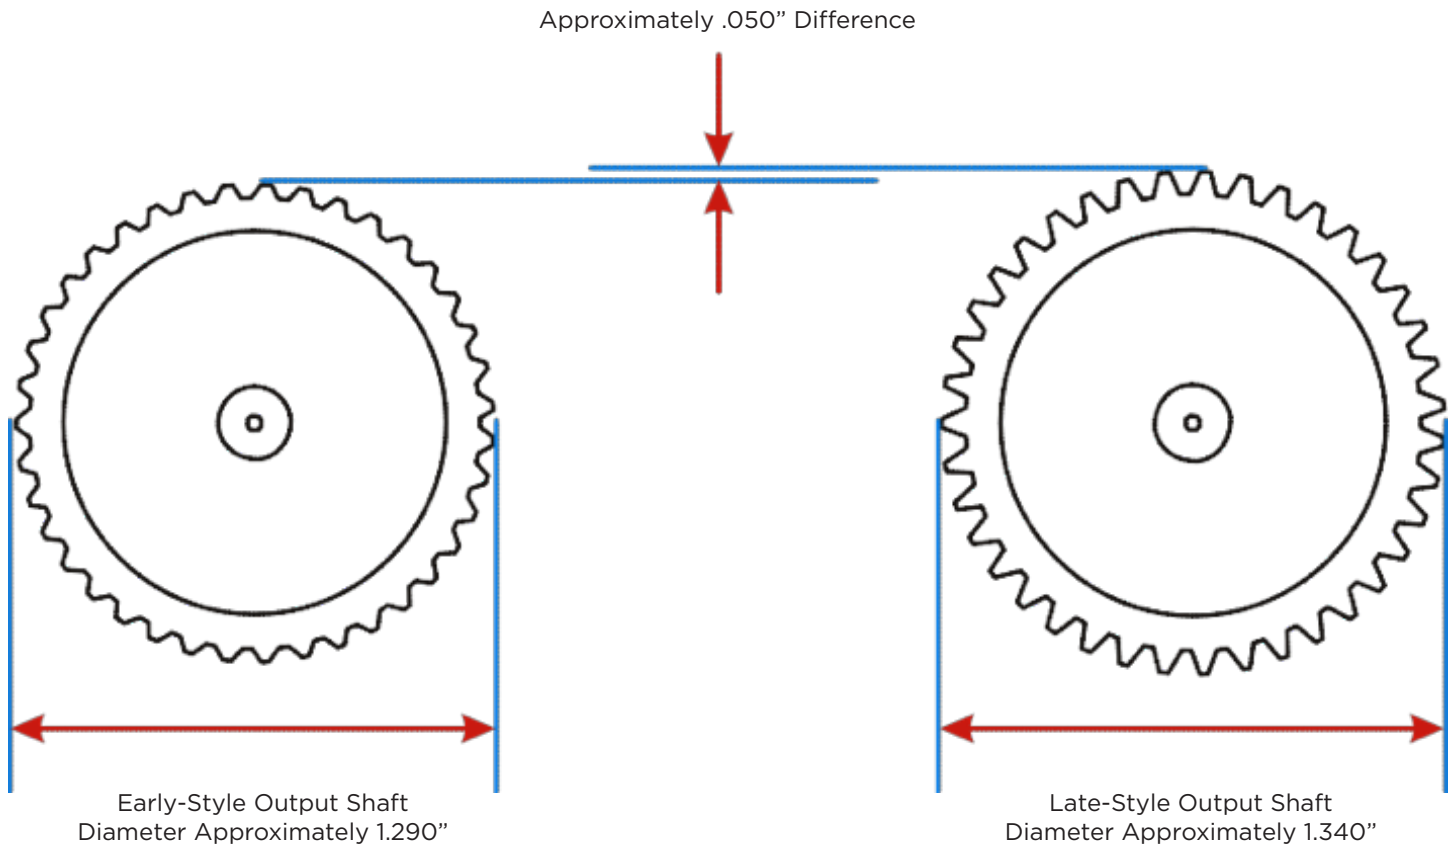
OUTPUT SHAFT DIFFERENCES

A late-style output shaft will not fit when used in conjunction with an early-style driveshaft yoke. The reason being the Chrysler Corporation changed the outside diameter of the output shaft in the spline area, which increased the contact area of the yoke splines for improved durability. The yoke changed, as well, to accommodate the output shaft change.

During the remanufacturing process, the output shaft has been machined to fit both the early- and late-style driveshaft yoke, eliminating the need to purchase and install a late-style driveshaft yoke.
