4F27E

INSTALLATION GUIDE

Ford Automatic Transmission

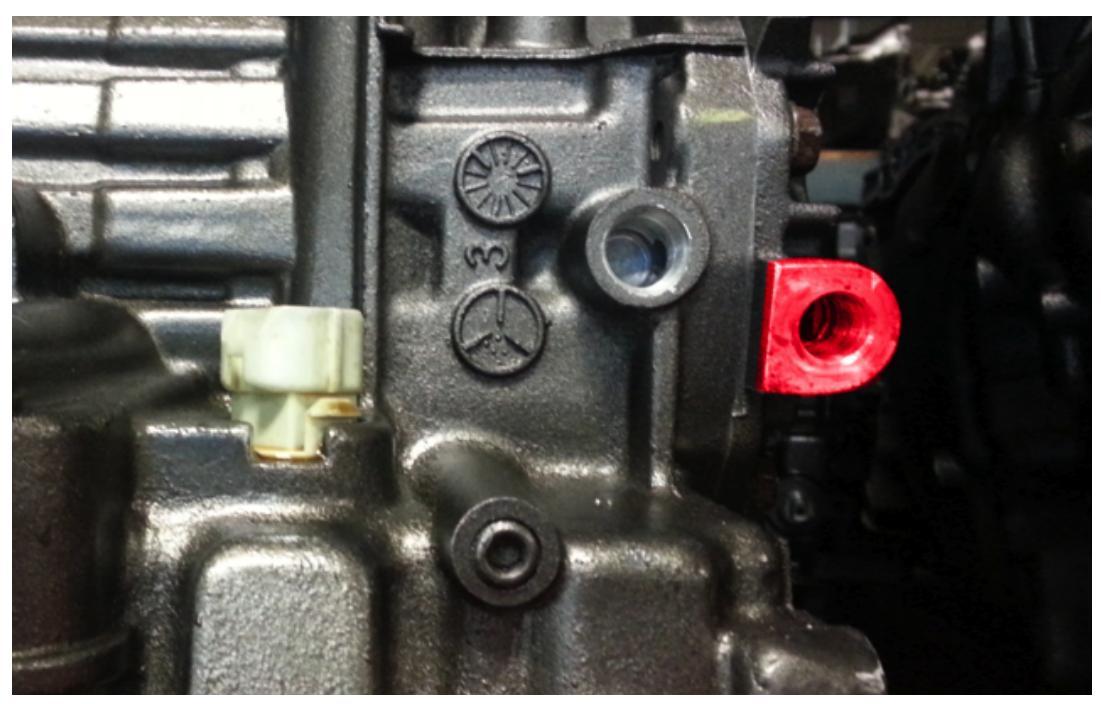
Due to premature rear cover failures in most Mazda applications, all of our remanufactured 4F27E (FN4A-EL) transmissions are updated with the improved Ford-designed rear cover.

UPDATED COOLER PORT SHOWN IN RED

The cooler return line must be relocated from the case to the end cover. During remanufacturing, the transmission is internally updated and the factory cooler line hole in the case is **permanently** sealed – all Ford applications will remain unmodified. Mazda units are updated to accept Mazda factory cooler line fittings (M14 x 1.50).

If you install the return cooler fitting into the original case location there will be no lubrication provided to the rear of the transaxle and immediate failure will result and is **not** covered under your warranty.
