## U151E, U151F & U250E INSTALLATION GUIDE

Toyota Automatic Transmission

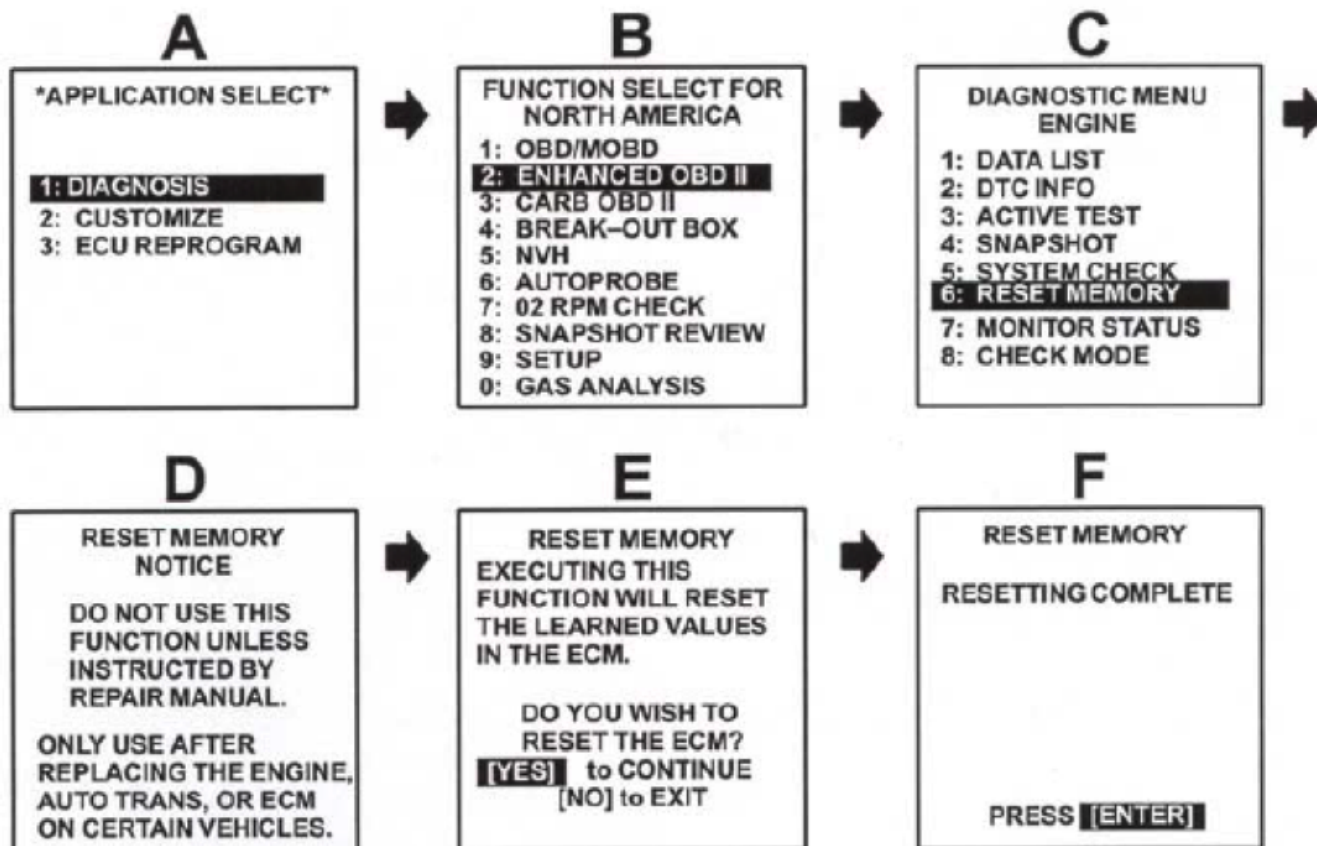
## ADAPTIVE MEMORY RESET

- Do not use power tools to tighten the manual lever retaining nut. The use of power tools can damage the internal linkage.
- Complete the Adaptive Memory Reset procedure for the ECM by using a capable scan tool. Disconnecting the battery is not sufficient to clear the adaptive memory. See next page for adaptive memory reset screenshots from a Toyota factory scan tool.
